REPORT NO. CG-D-24-77

EVALUATION OF PROTECTIVE
COATINGS SYSTEMS FOR BUOYS

May 31, 1977

FINAL REPORT

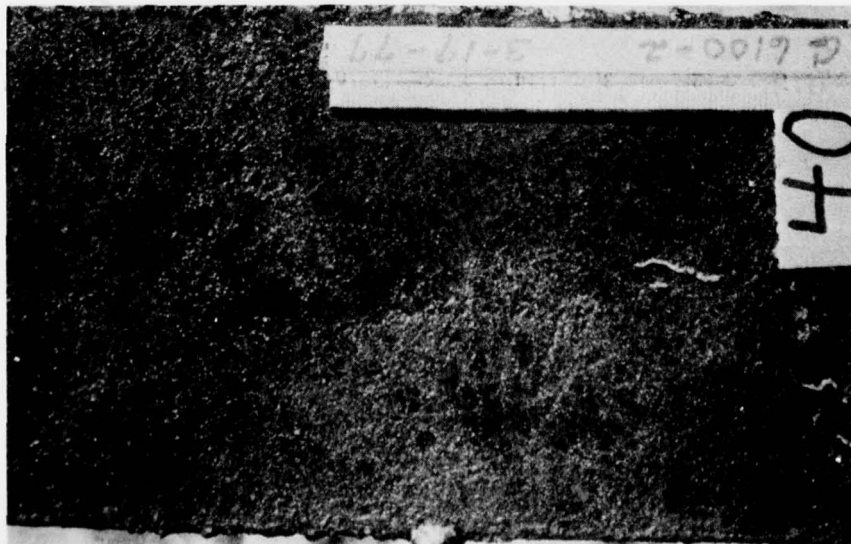
Panel No. 40
System No. CG-19
Type 121/63 Vinyl High
Rosin Control on Steel

18 Months' Exposure

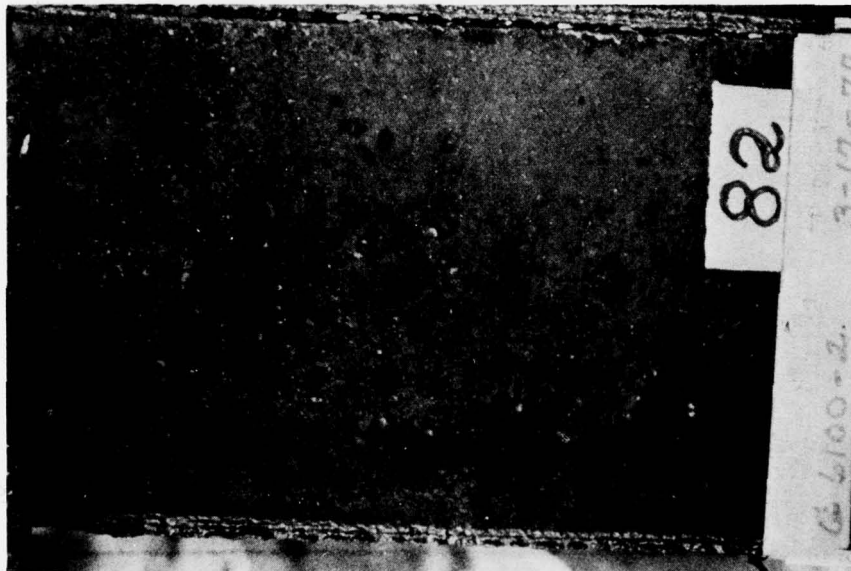
Panel No. 82
System No. CG-20
Elastomeric Sheet With Organotin
Toxicant on Steel

18 Months' Exposure

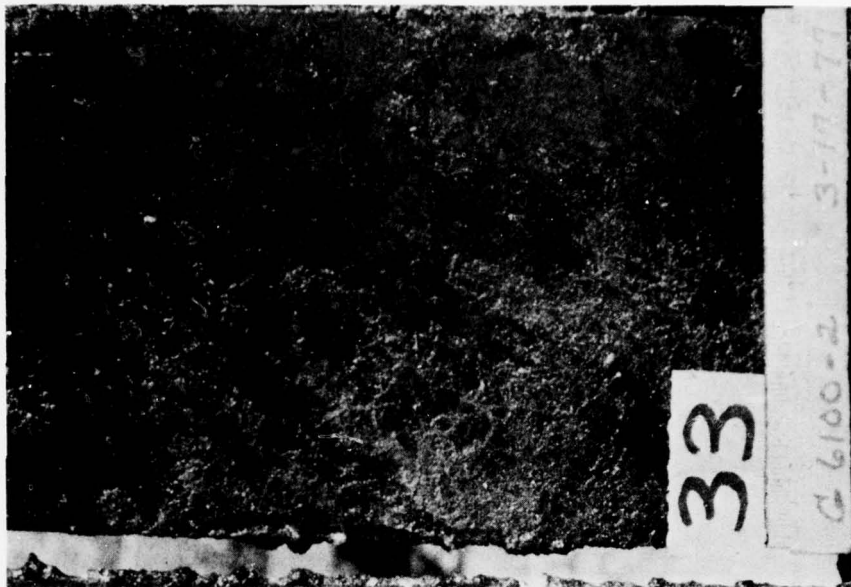
Panel No. 33
System No. CG-21
Type 121 Standard Vinyl
Rosin Control on Steel

18 Months' Exposure

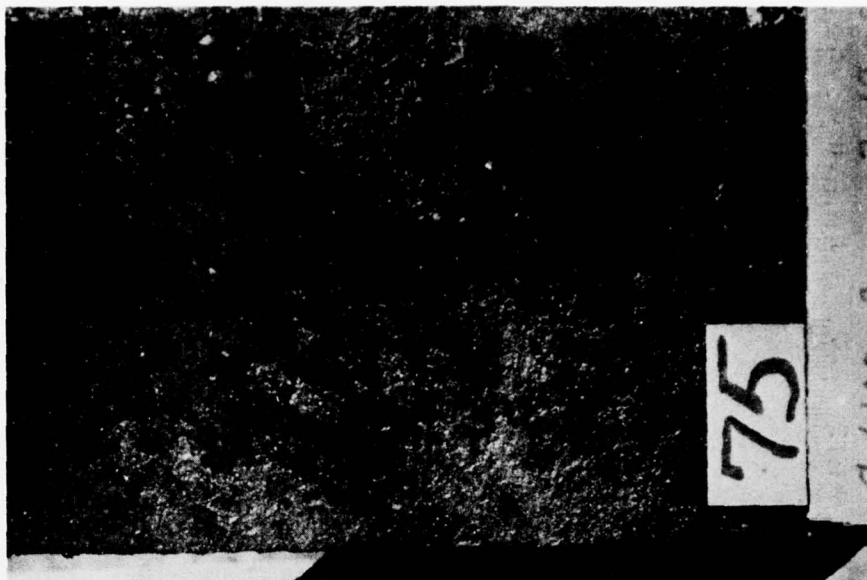
Panel No. 75
System No. CG-24
Epoxy Primer Standard Vinyl
Rosin Control on Steel

18 Months' Exposure

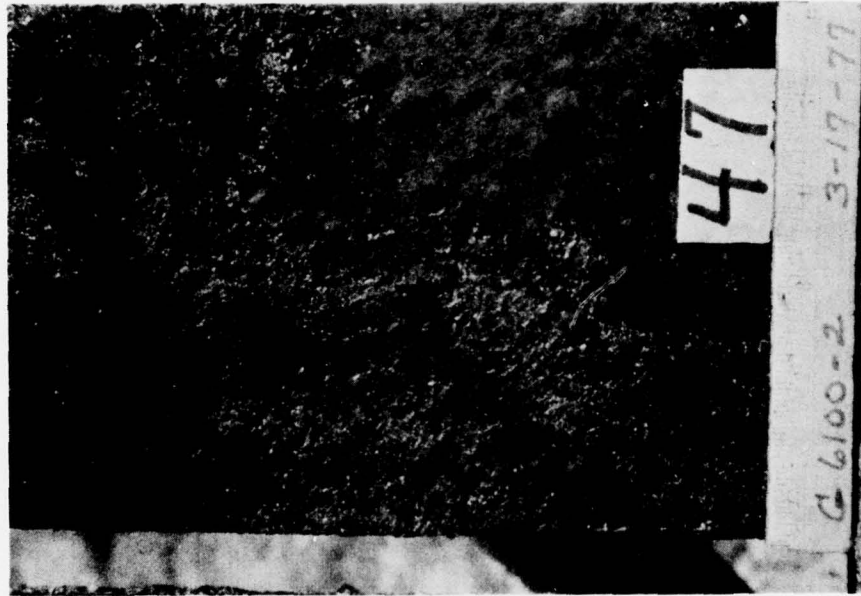
Panel No. 47
System No. CG-26
Type 121 Applied Over Sanded
Polyester Glass Flake
Anticorrosive on Steel

18 Months' Exposure

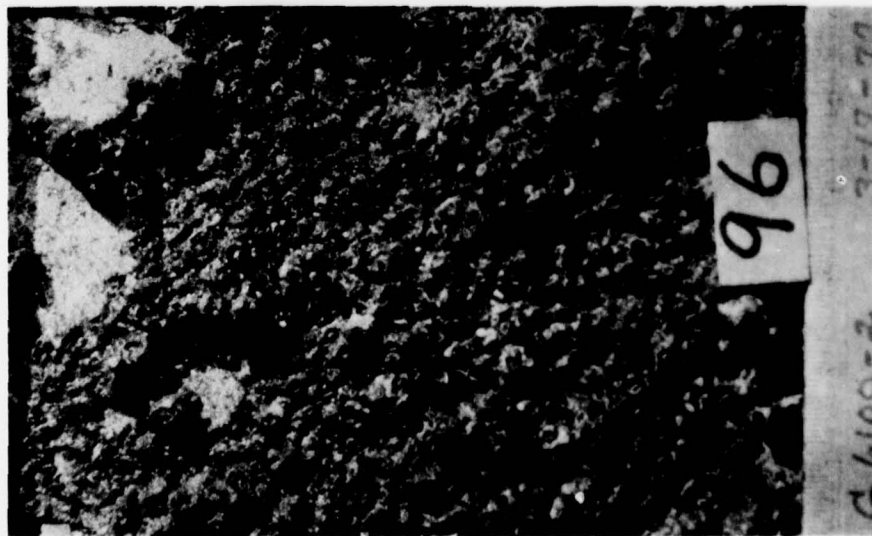
All of the copper-coated panels failed by loss of adhesion of the cladding to the substrate.

Panel No. 96
System No. CG-28
Flame Sprayed Copper
Cladding over Polyester
Glass Flake on Steel

18 Months' Exposure

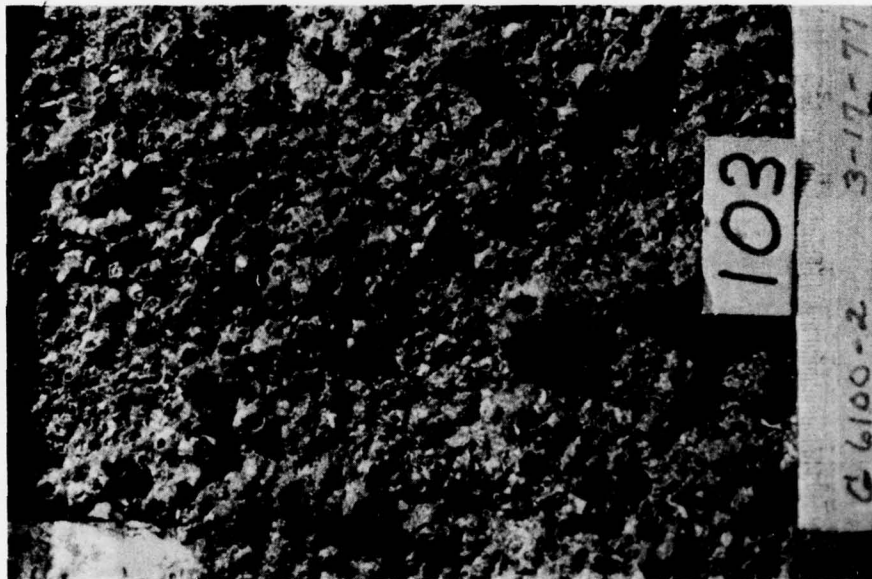
It is felt that the acrylic-organometallic polymers offer considerable promise as a new class of antifouling materials. Coatings in the present study failed primarily because they were prepared in the laboratory as an early, one-time attempt to obtain satisfactory pigmentation. Large-scale pigmentations studies are currently in progress which could resolve most or all of the problems encountered here. The upgraded materials should be considered for additional buoy studies because they appear to be excellent candidates for meeting all of the U. S. Coast Guard's stringent requirements for buoy materials.

Panel No. 103
System No. CG-29
Acrylic-Organometallic Toxic
Polymer Over Type 119
Anticorrosive on Steel

18 Months' Exposure

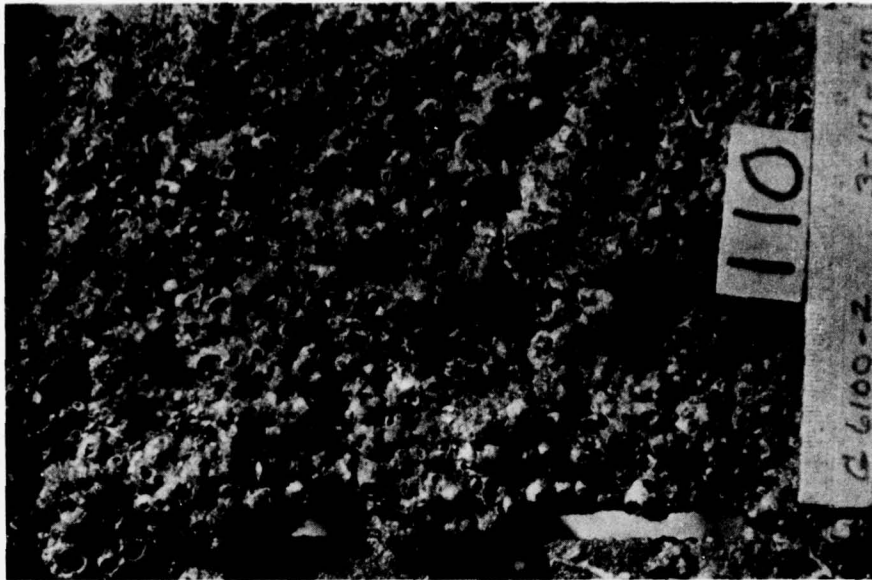
Panel No. 110

Uncoated Steel Control Panel

18 Months' Exposure

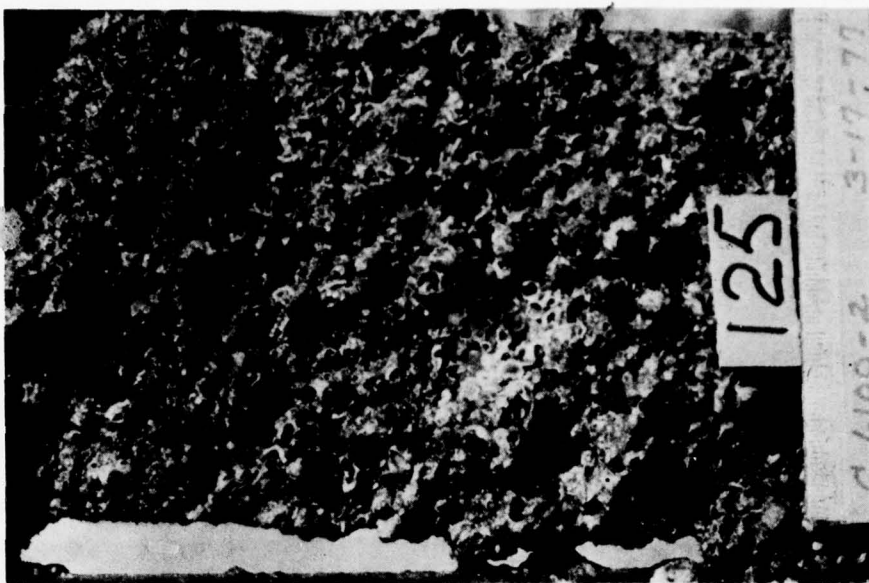
Panel No. 125
System No. CG-32
Acrylic-Organometallic Toxic
Polymer on Aluminum

18 Months' Exposure

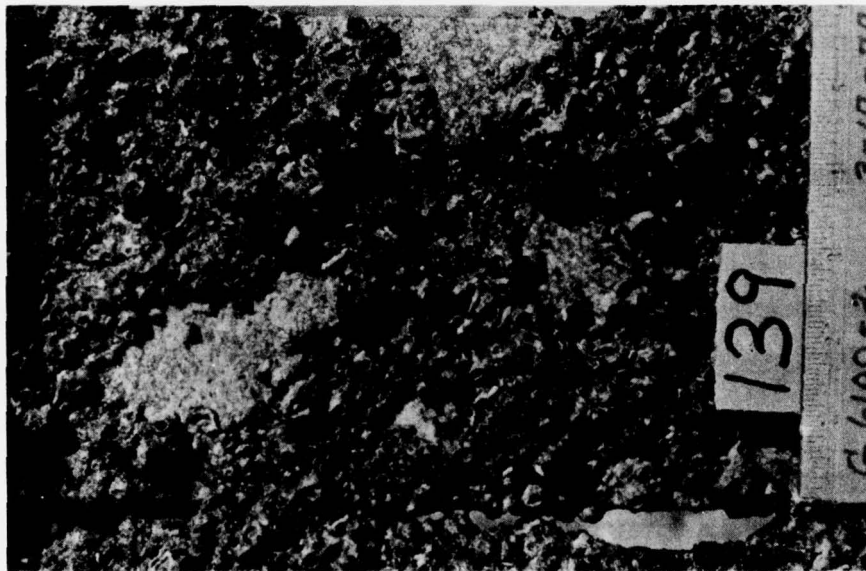
Panel No. 139

Uncoated Aluminum Control Panel

18 Months' Exposure

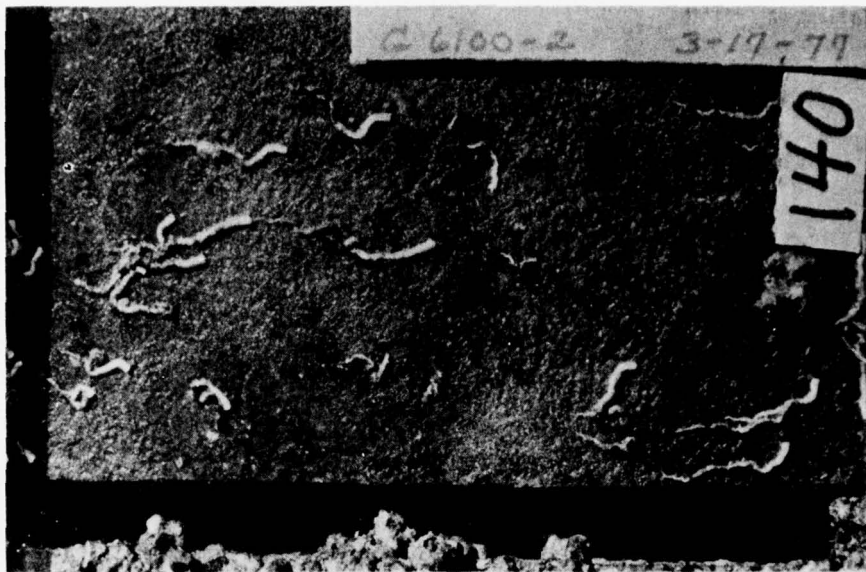
Of interest is the performance of the Type 121/63 system on plastic substrate (System CG-34). After 18 months of immersion, three of the damaged CG34 panels are rated 10- but one is rated 8 and two others are rated 7 for fouling. There is a trace of peeling present which indicates that there may be a long-term adhesion problem over plastic. Further study is required before valid conclusions can be made.

Panel No. 140
System No. CG-34
Type 121/63 Vinyl-High
Rosin Control on Plastic

18 Months' Exposure

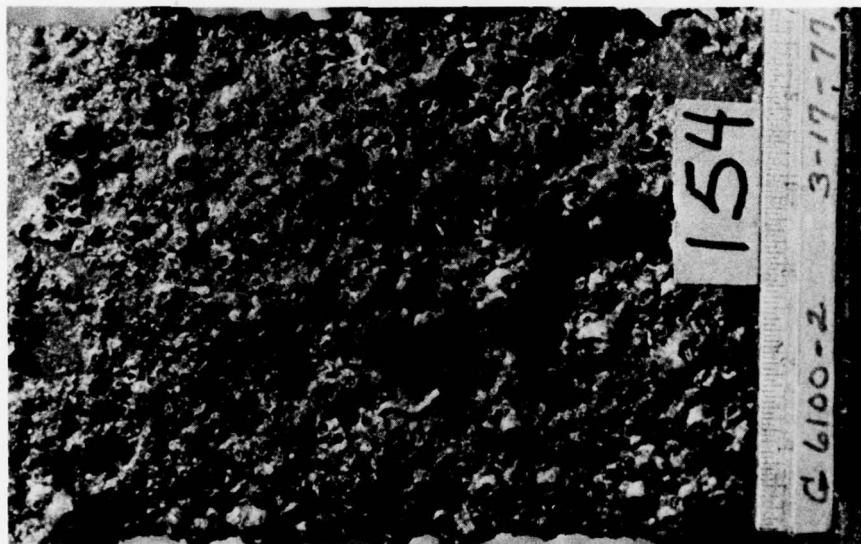
Panel No. 154
System No. CG-36
Acrylic-Organometallic Toxic
Polymer on Plastic

18 Months' Exposure

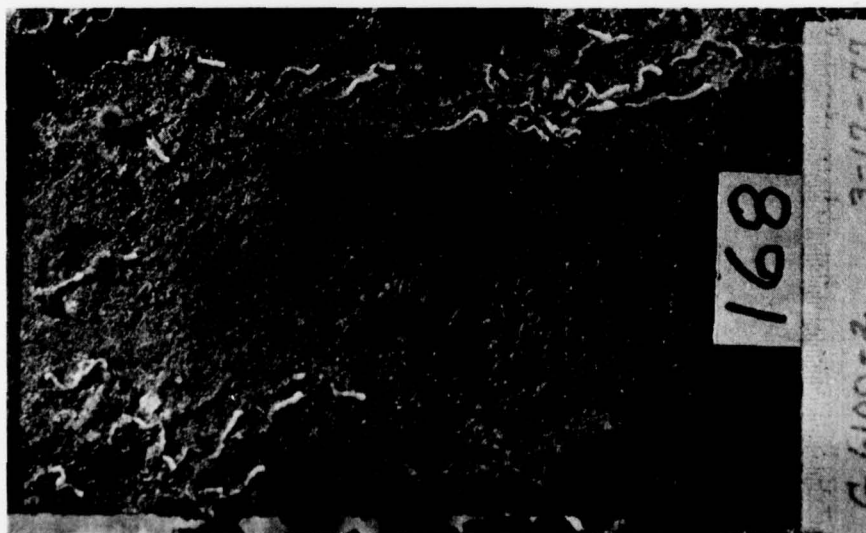
Panel No. 168
System No. CG-38
Flame-Sprayed Copper
Cladding on Plastic
18 Months' Exposure

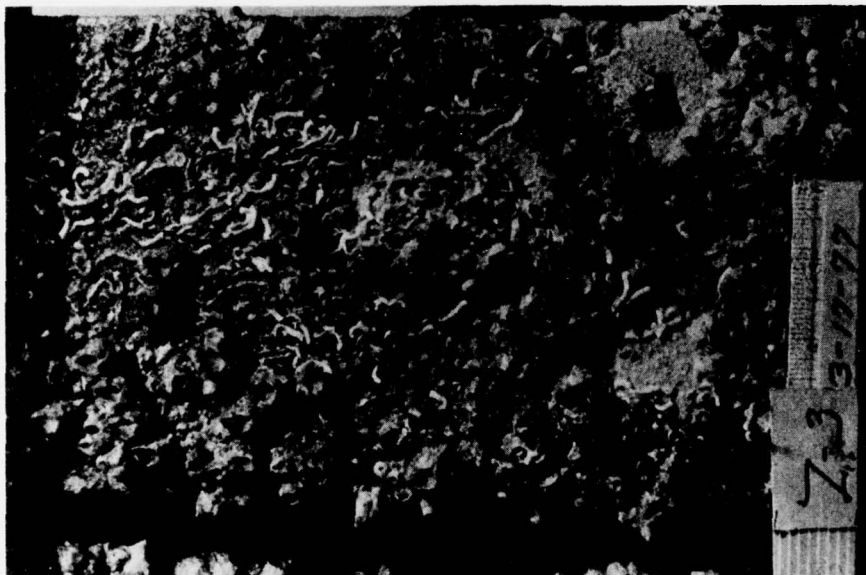
The nonsolvent polyurethane was found totally lacking in antifouling properties. However, its physical and anti-corrosive properties are outstanding and may justify some effort to obtain antifouling properties as well.

Panel No. Z3
System No. CG-40
Nonsolvent Polyurethane
on Steel
18 Months' Exposure

Second priority should be placed on improving the performance of systems which failed early in the present program. A modest program could be undertaken to provide some measure of fouling resistance to the nonsolvent polyurethane system. The U. S. Navy toxic organometallic polymer has been the subject of several pigmentation studies and the most successful formulation could be added to the buoy program. Inquiries could be made into the possibility of increasing the film density and the topcoat adhesion of the flame-sprayed copper cladding. In addition, the door should be left open to enter new commercial materials into the program as they became available.

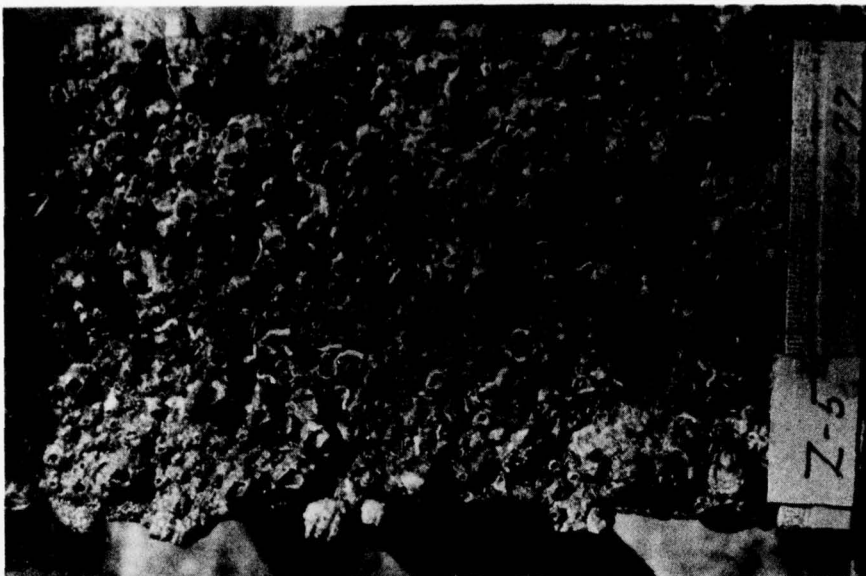
Panel No. Z5
System No. CG-41
Nonsolvent Polyurethane
on Aluminum
18 Months' Exposure

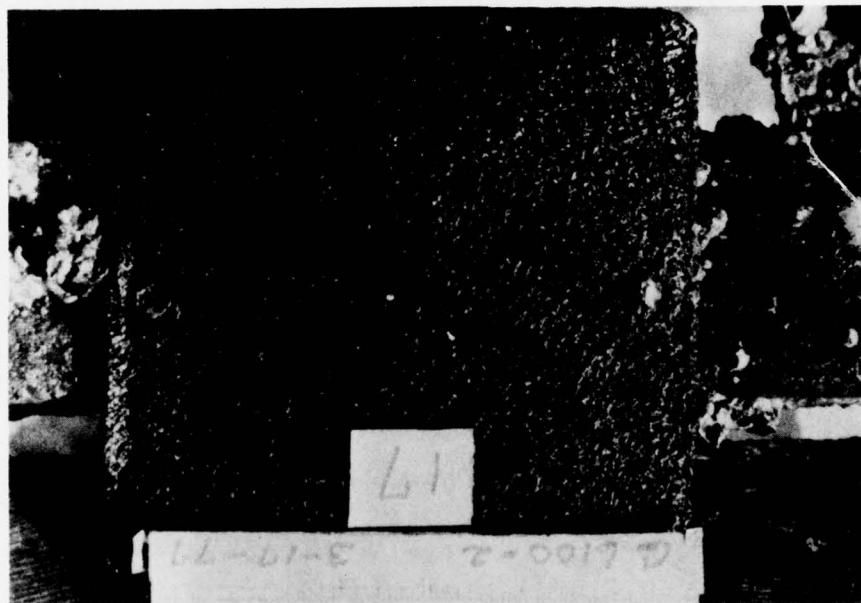
Panel No. 17
System No. CG-17
Elastomeric Sheet With
Organotin Toxicant

77 Months' Exposure

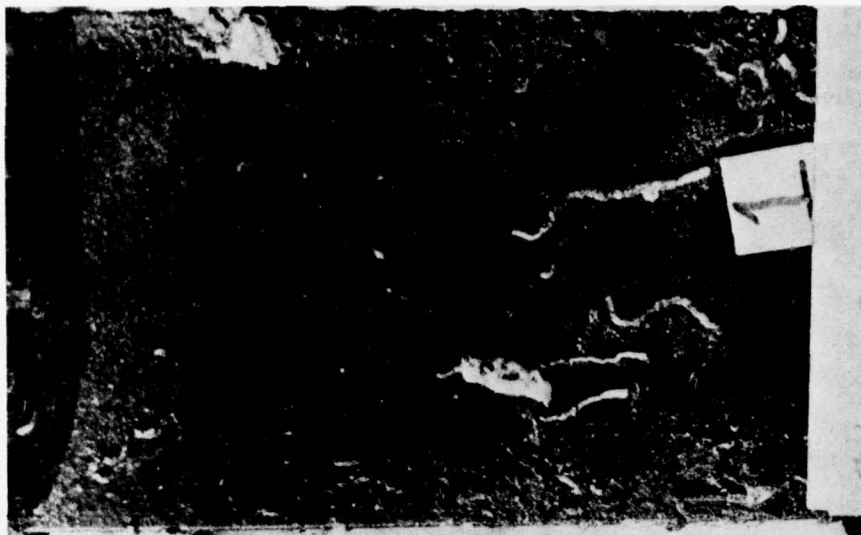
Panel No. 1
System No. CG-1
Type 121 Standard Vinyl-
Rosin Control

77 Months' Exposure

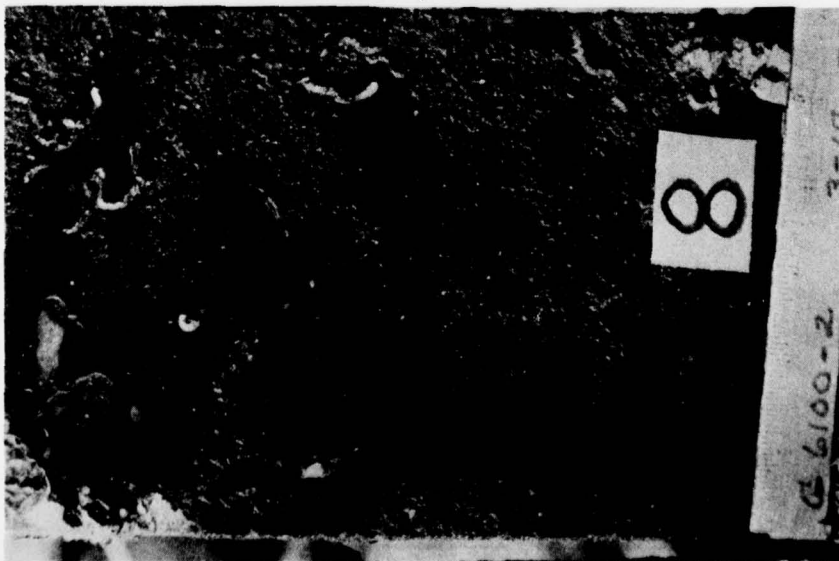
Panel No. 8
System No. CG-4
Self-Cure Zinc Silicate High-Build
Vinyl, Type 121 Antifoul

77 Months' Exposure

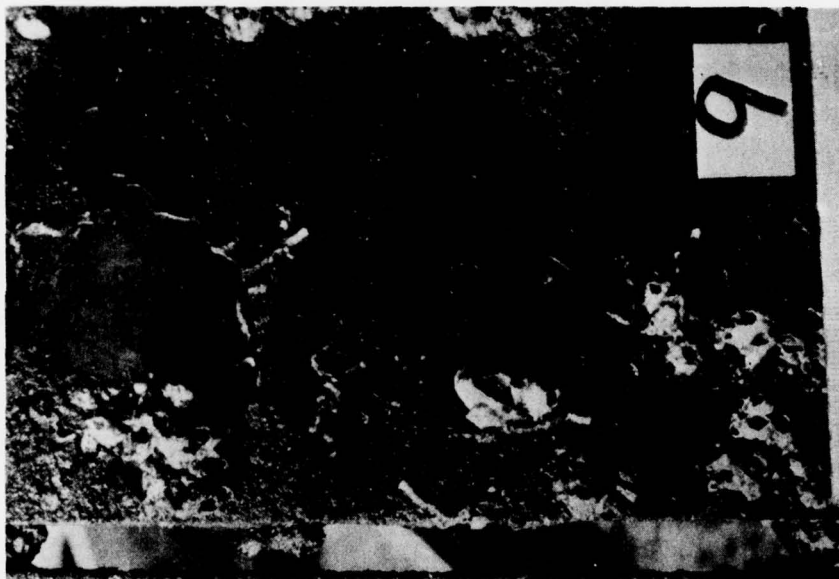
Panel No. 9
System No. CG-1
Postcure Zinc Silicate, High-Build
Vinyl, Type 121 Antifoul

77 Months' Exposure

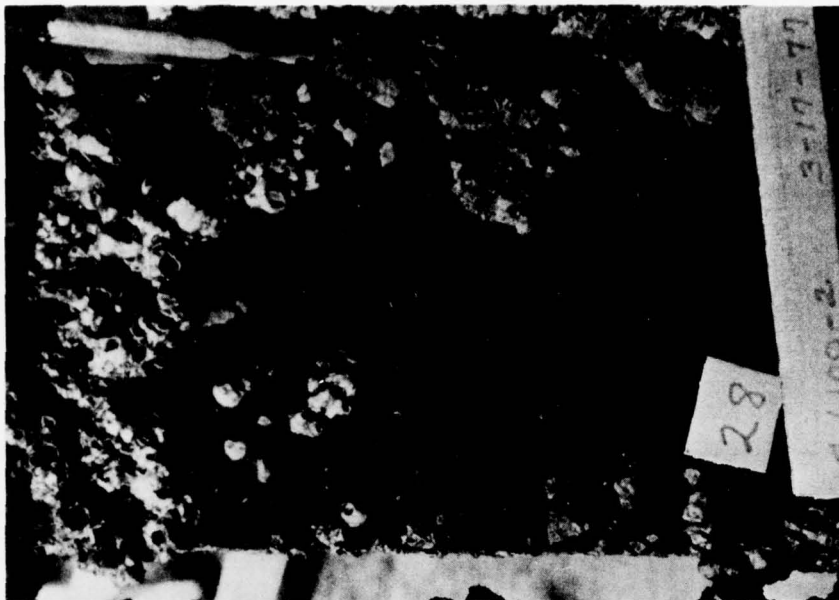
Panel No. 28
System No. CG-14
Vinyl-Rosin with Organotin (TBTF)
Toxicant, Aluminum Substrate

77 Months' Exposure

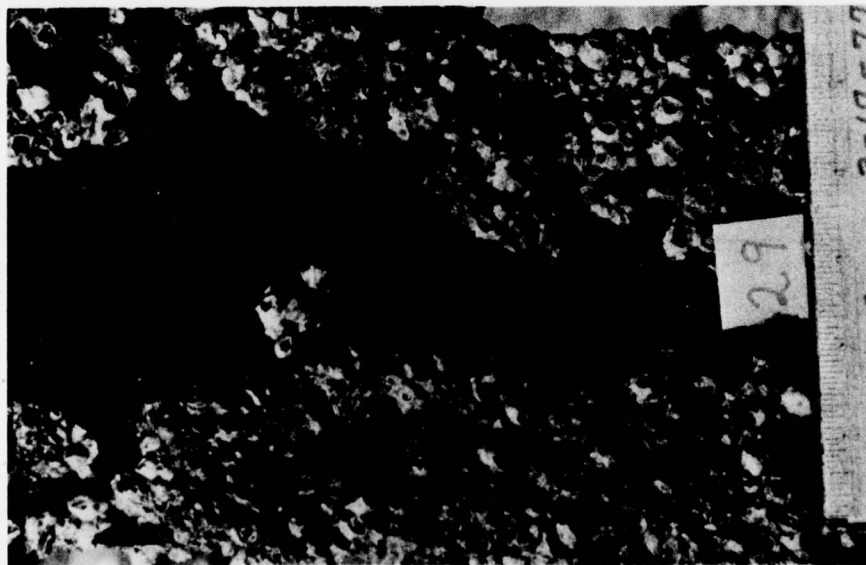
Panel No. 29
System No. CG-15
Vinyl-Rosin With Organotin (TBTF)
Toxicant, Fibreglass Substrate

77 Months' Exposure

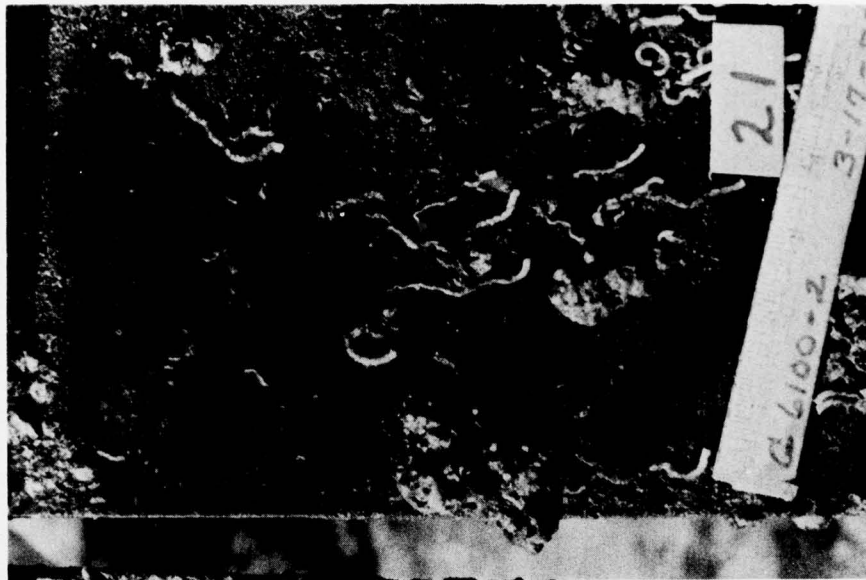
Panel No. 21
System No. CG-11
Epoxy Primer, Epoxy-Coal
Tar Anticorrosive and Antifoul

77 Months' Exposure
